PHASE I ENVIRONMENTAL SITE ASSESSMENT

**3668 RIVERTOWN PARKWAY SW
CITY OF GRANDVILLE, MICHIGAN**

**UNDERGROUND BUILDING
MAINTENANCE LLC
6568 CENTER INDUSTRIAL DRIVE
JENISON, MICHIGAN**

AUGUST 4, 2022

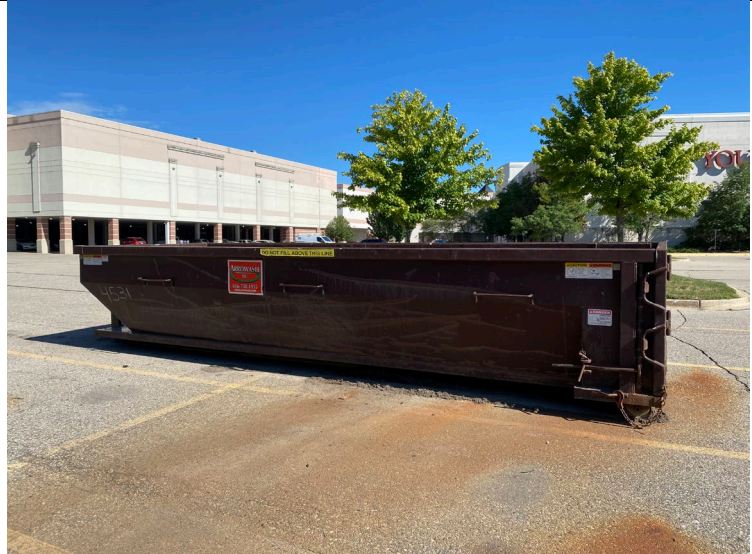
Staining is evident on the asphalt parking surfaces, near the dumpster and loading dock. The staining is small and isolated. The hard surfacing is not saturated and the staining is not located near any penetrations or migration pathways.

DUMPSTER WITH DE MINIMIS
STAINING

Stains are evident on the surface parking lot. The asphalt in these areas is not saturated. Staining is not near any cracks, expansion joints or drains. The stains appear limited to the surfaces and no potential migratory pathways are evident. Because of these factors, it is our professional opinion that surface staining evident at the Subject Property is *de minimis* and not evidence of a REC.

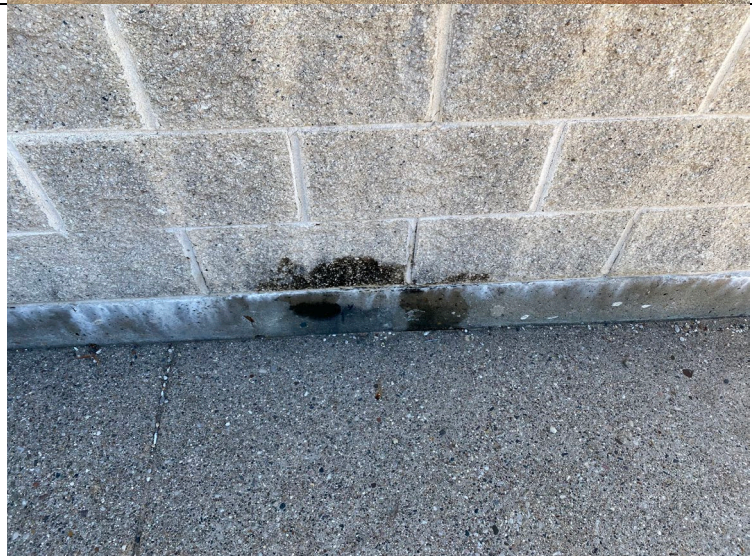
DE MINIMIS STAINING

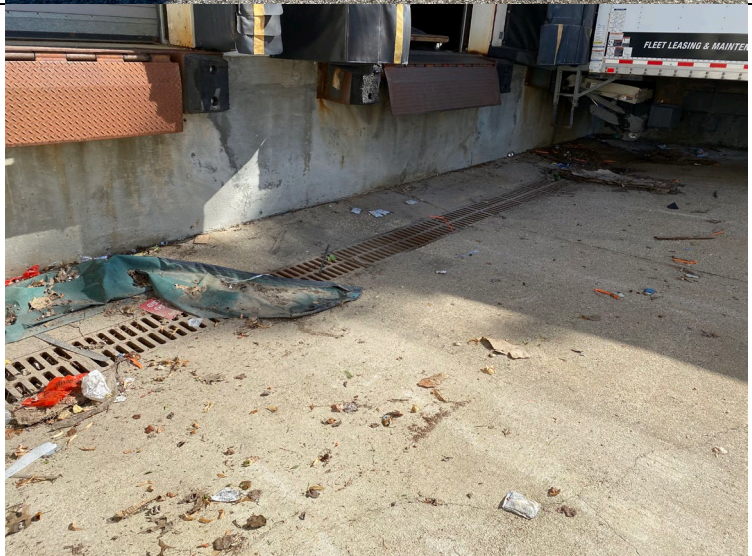
Several discharge features are evident on the Subject Property including floor drains and storm water catch basins. These features are free and clear and do not exhibit stains or odors. The drains discharge offsite to the municipal system.

EXTERIOR FLOOR DRAINS

Floor drains and storm water catch basins are evident on the Subject Property. These features are free and clear and do not exhibit stains or odors. The storm and floor drains are believed to discharge offsite to the municipal system. Because of these factors, it is our professional opinion that the discharge features on the Subject Property are not a REC.
